MA HAWKEYE ROOM-BY-ROOM

1234 Main Street
Marblehead, MA 01945

Buyer Name
11/23/2025 9:00AM

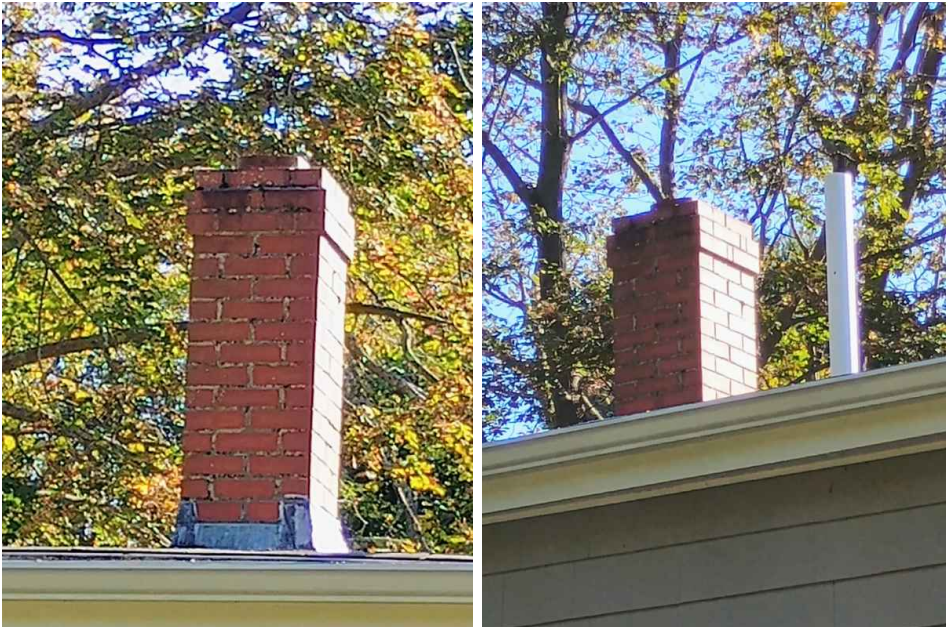
3.4.1 Chimney

CHIMNEY CAP MISSING

No chimney cap was observed. This is important to protect from moisture intrusion and protect the chimney. Recommend a qualified roofer or chimney expert install.

**Note - No flues or fireplaces are drafting through the chimney. Top of chimney may be capped and not in use. Verify with sellers regarding the use of the chimney.

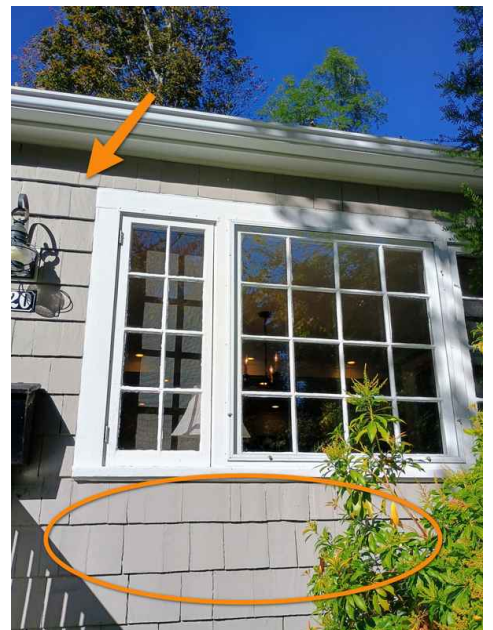
4.2.1 Siding, Flashing & Trim

Siding shingles was splitting in one or more areas, which can lead to moisture intrusion and/or mold. Recommend monitoring for excessive splitting, in which case a qualified siding contractor should evaluate and repair/replace.

Contact a qualified professional.

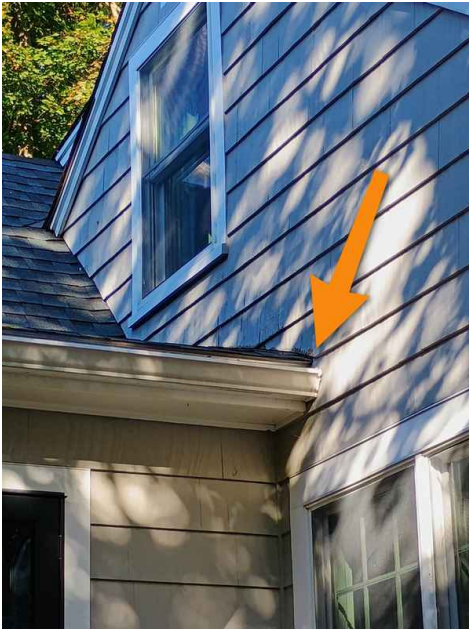
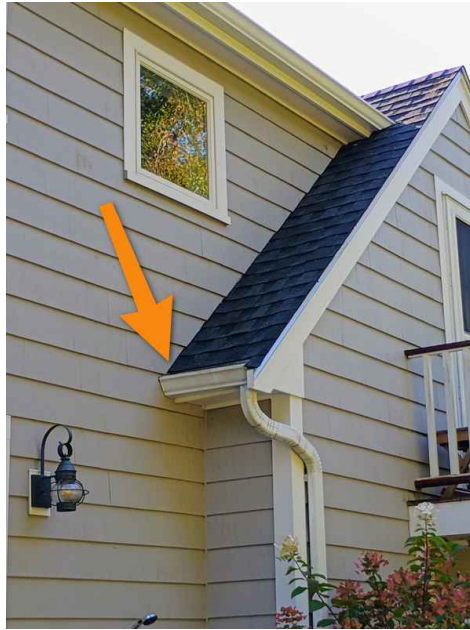
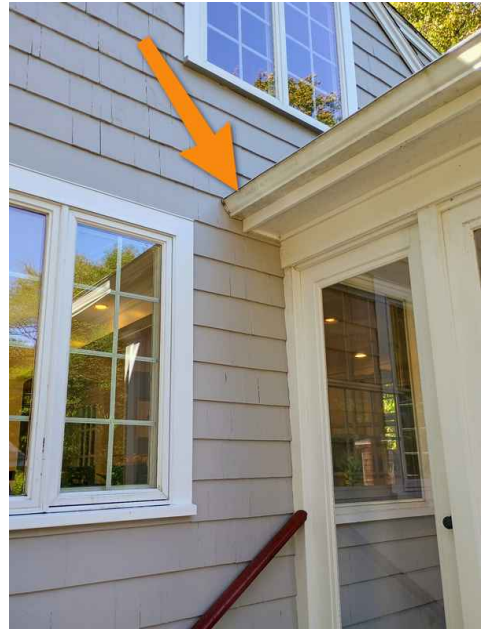
4.2.2 Siding, Flashing & Trim

KICKOUT FLASHING(S) MISSING

Contact a qualified professional.

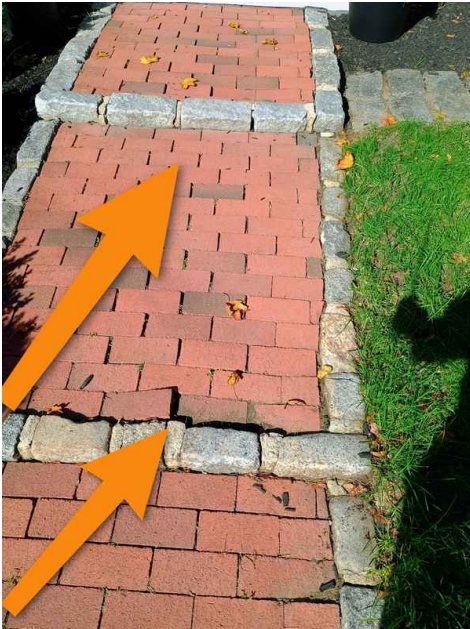
4.4.1 Walkways, Patios & Driveways

WALKWAY - SHIFTED BRICKS: TRIP HAZARD

Shifted bricks were observed in the walkway, creating a potential trip hazard. The shifting may be caused by poorly compacted earth beneath the walkway. Recommend a walkway contractor or mason repair as desired.

Contact a qualified professional.

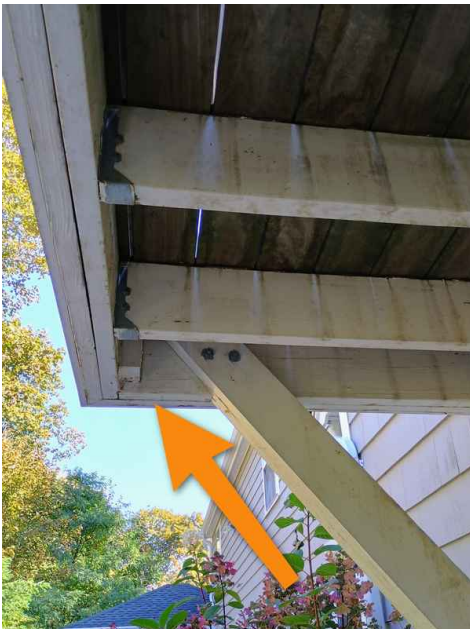
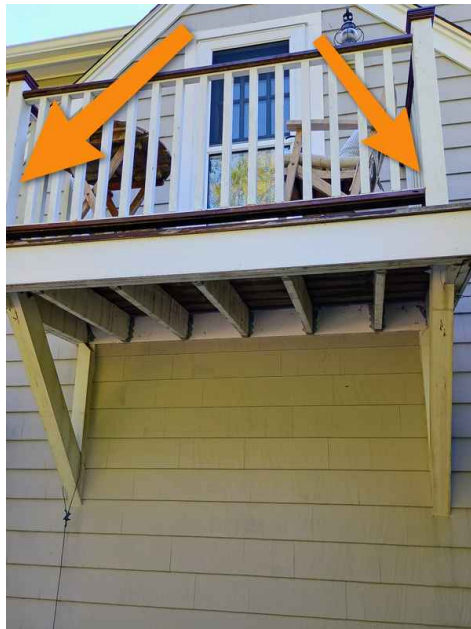
4.5.1 Decks, Balconies, Porches & Steps

many decks are built with guardrails that use notched 4x4's as rail posts. Regardless of the depth of the notch this is inadvisable because it significantly weakens the strength properties of the posts.

Monitor for weakening and correct if and as needed.

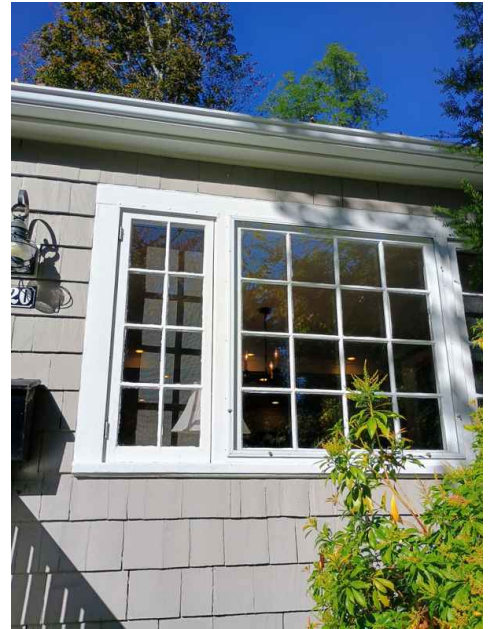
4.8.1 Windows (As viewed from the exterior)

WINDOW GLAZING DETERIORATED

Glazing at older wood windows shows cracking, peeling. Recommend repair to prevent water intrusion.

Contact a qualified window repair/installation contractor.

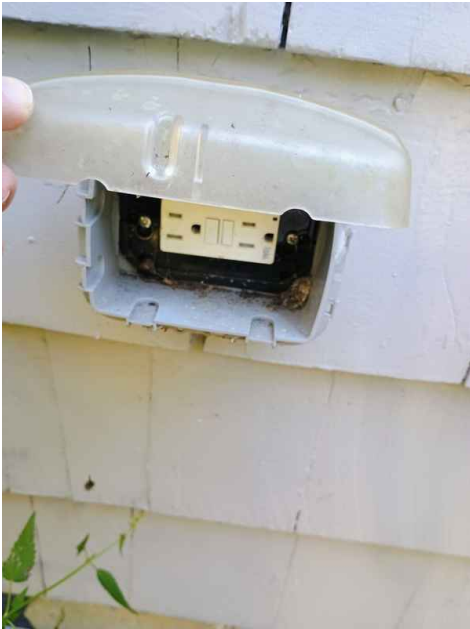
4.12.1 Exterior Outlets

NOT WORKING GFCI

The rear exterior gfci outlet is not working. Repair as needed.

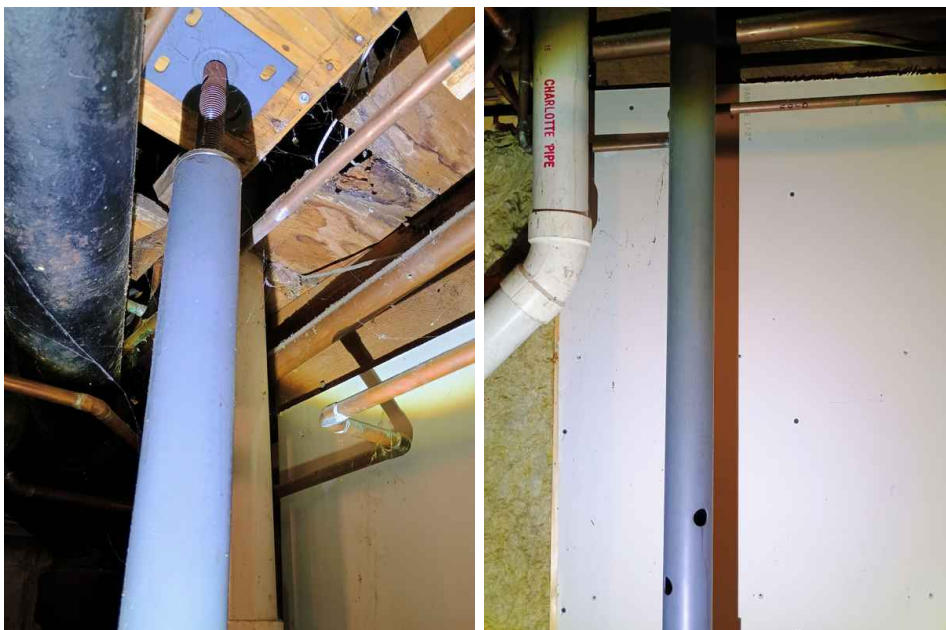
TEMPORARY SUPPORTS

When any of these split type or telescopic adjustable post or columns are installed with the intention of permanent use for the support of main beams in homes it is an improper and unsafe application for which they were not designed. All "split type" adjustable posts are for temporary use only.

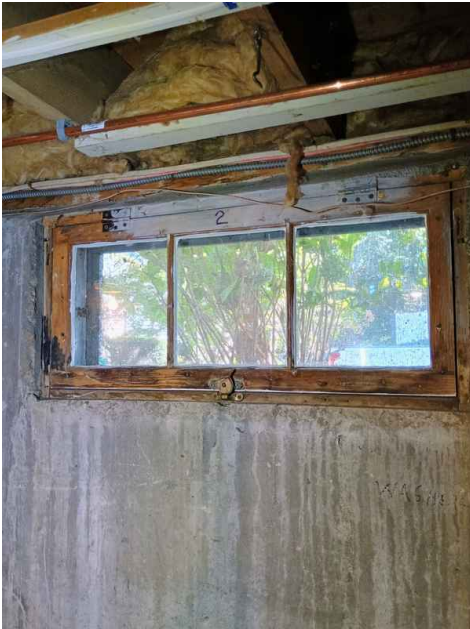
6.12.1 Basement Windows

UPGRADE WORN WINDOWS

Consider upgrade or refurbishing of worn windows. Upgrade rotted and deteriorated windows as needed.

Contact a qualified professional.

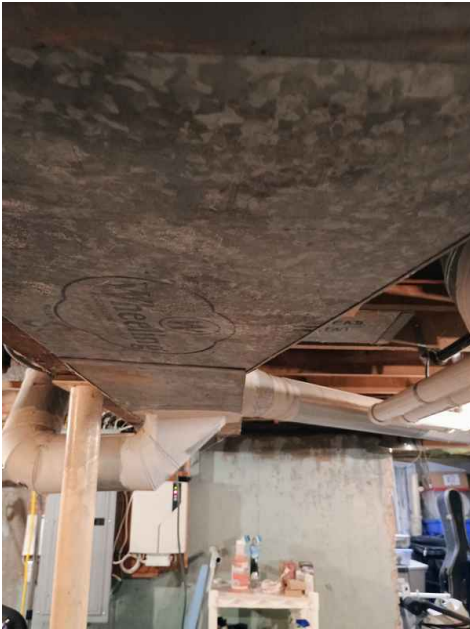
Ducts are not insulated, resulting in energy loss. Recommend licensed HVAC contractor insulate ducts.

Contact a qualified HVAC professional.

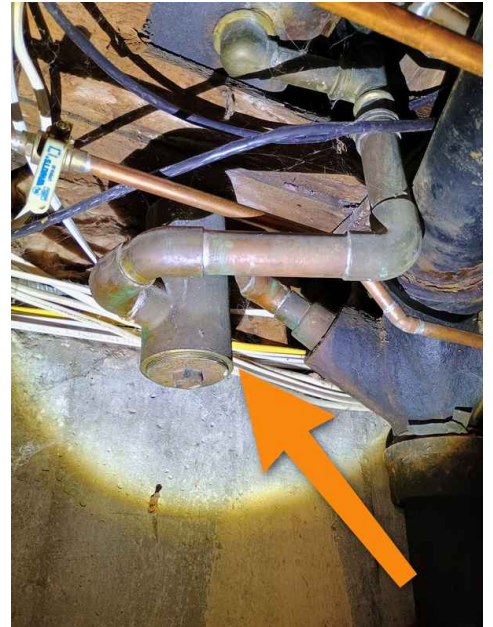
Drum trap present. They can be problematic because they are prone to clogging and are not easily accessible for cleaning or maintenance. Additionally, drum traps do not provide the same self-scouring action as modern P-traps, which can lead to debris buildup and slow drainage. While the drum trap may be functional at the time of inspection, replacement with a modern, code-compliant P-trap is recommended during future renovations or if drainage issues occur. Evaluation and further recommendations by a licensed plumber are advised.

Contact a qualified plumbing contractor.

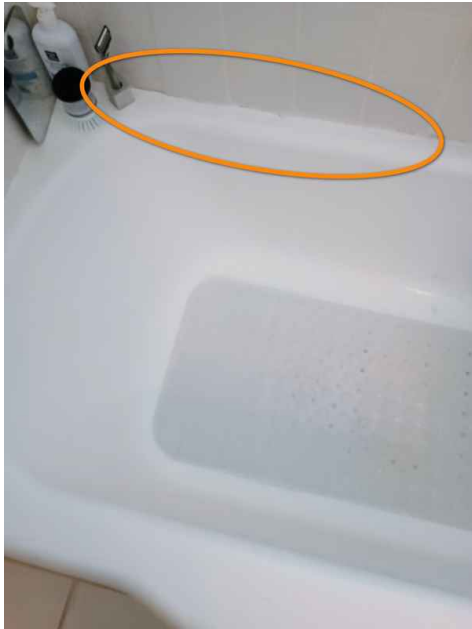
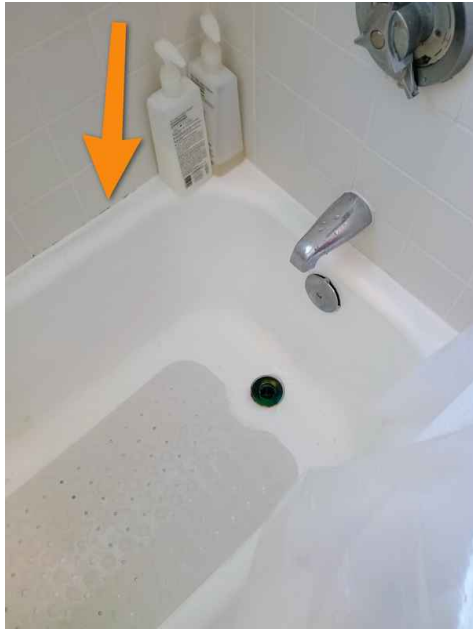
Caulking/grout repairs are needed for the tub/shower enclosure. Regular maintenance of tile caulk and grout is critical for moisture control.

Contact a qualified tile contractor

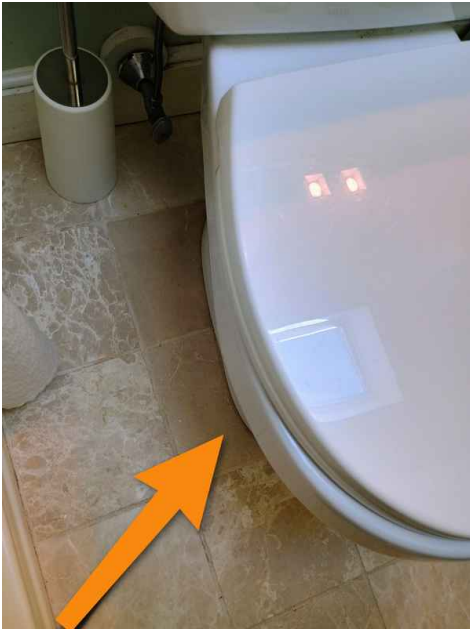
LOOSE TOILET

Loose toilet observed. Remove, evaluate flange and floor, reseal with new wax ring and repair. Check flooring in toilet area for possible concealed damage. Failure to properly reseal the toilet may result in damage to the floor and substructure.

Toilet was loose on its moorings

Contact a qualified professional.

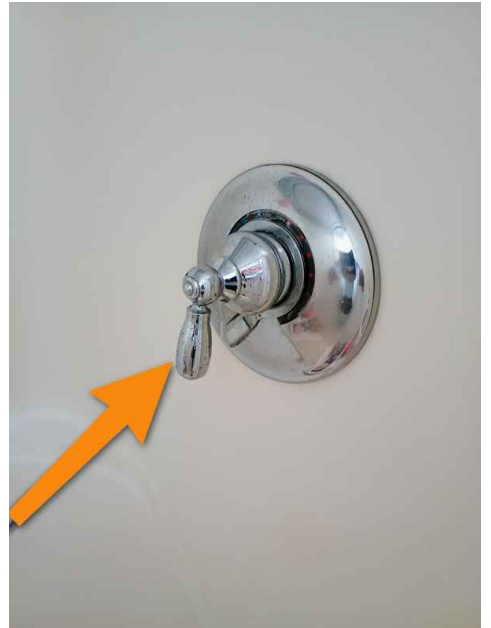
13.4.1 Shower / Tub

LOOSE VALVE HANDLE

Shower control valve handle was loose. Correct this condition.

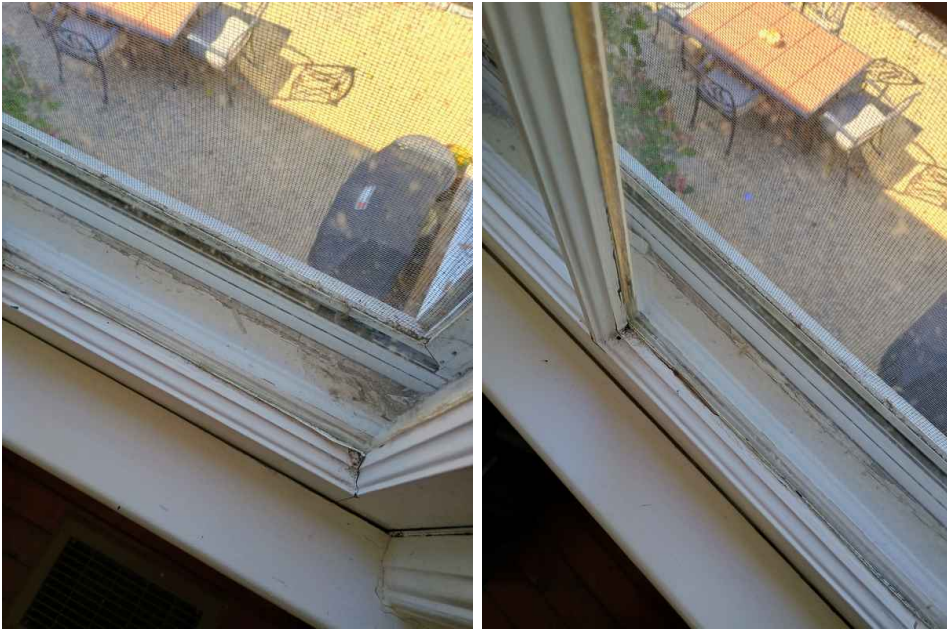
DAMAGED

One or more windows appears to have general damage, but are operational. Recommend a window professional clean, lubricate & adjust as necessary.

Glazing has deteriorated on the outside of several wood windows. Some proper maintenance would correct this condition.

Contact a qualified window repair/installation contractor.

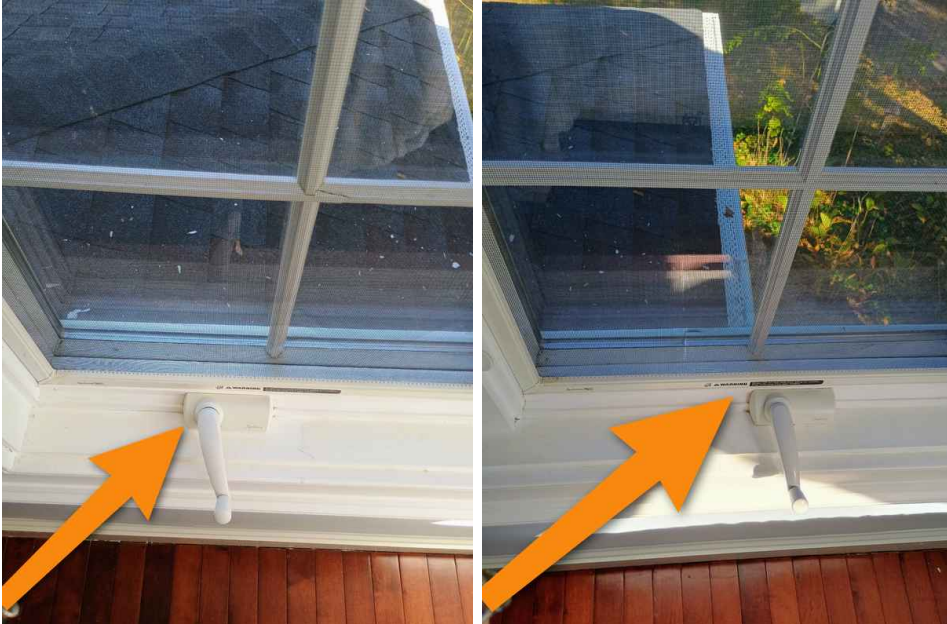
17.3.2 Windows

DAMAGED CRANK HARDWARE

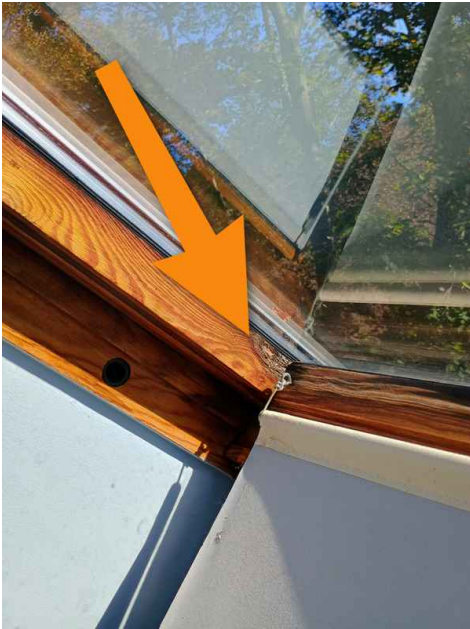
17.3.3 Windows

SKYLIGHTS SHOW SOME WATER DAMAGE

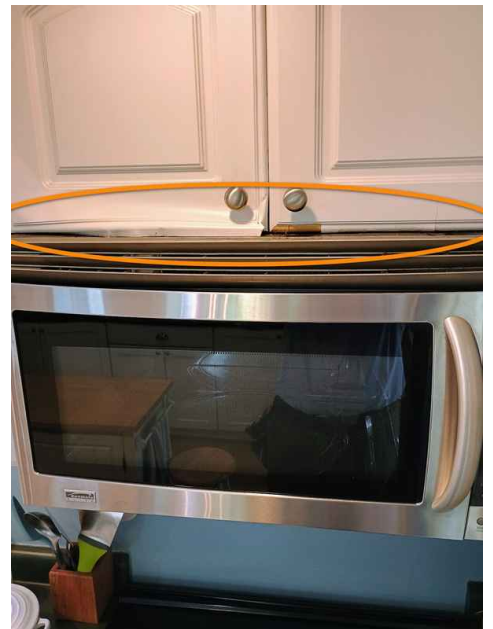
24.2.1 Kitchen Countertops/ Cabinets

DAMAGED CABINET DOOR(S)

Thermofoil cabinet doors show delamination
